STANDING COMMITTEE ON HABITAT ON THE PROGRESS MADE ON RURAL WATER SUPPLY AND LAND SERVICING

OSHIKOTO, OSHANA, OHANGWENA, OMUSATI, KUNENE, KAVANGO EAST, KAVANGO WEST, ZAMBEZI, OTJOZONDJUPA, OMAHEKE, HARDAP AND //KARAS REGIONS

02 - 28 JULY 2017

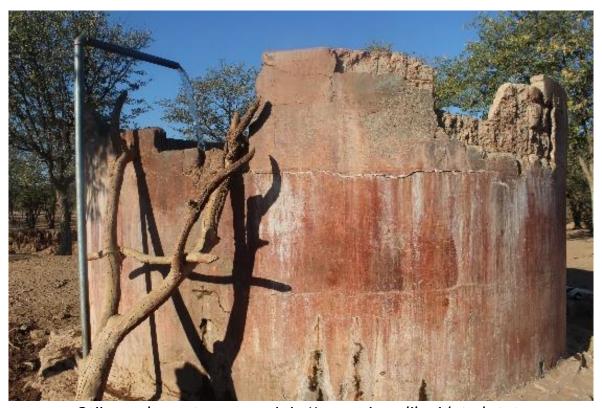
Otjingambu water reservoir in Kunene in a dilapidated state

- 5.21 Most boreholes in the Kunene region needed urgent repair, especially the boreholes of Otjingambu (*see cover page picture*) in Ohungumure, Okarukoro borehole in Okarukoro, and the Omumbonde borehole.

9.6 Many rural water supply infrastructure, especially boreholes, had multiple functional deficiencies and requests for reparations had long been made, but boreholes still malfunctioned during the visit, even for years before then.

- 9.7 The centralised procurement procedure delayed activities such as the reparation endeavours. The procurement process was such that approval was only done at Central Government, and any arrangement to the alternative had to be endorsed by the Ministry of Finance.
- 9.8 The situation was very dire to an extent that even acquiring small spare parts for the infrastructure had to be subjected to those cumbersome procurement procedures. Cars were always not in good repair to respond to concerns in remote areas.
